Structure Inhomogeneity and Failure Analysis of Modern Pipe Steels

A.A. Kazakov,* O.V. Kurochkina,* E.I. Kazakova,* and D.V. Kiselev *

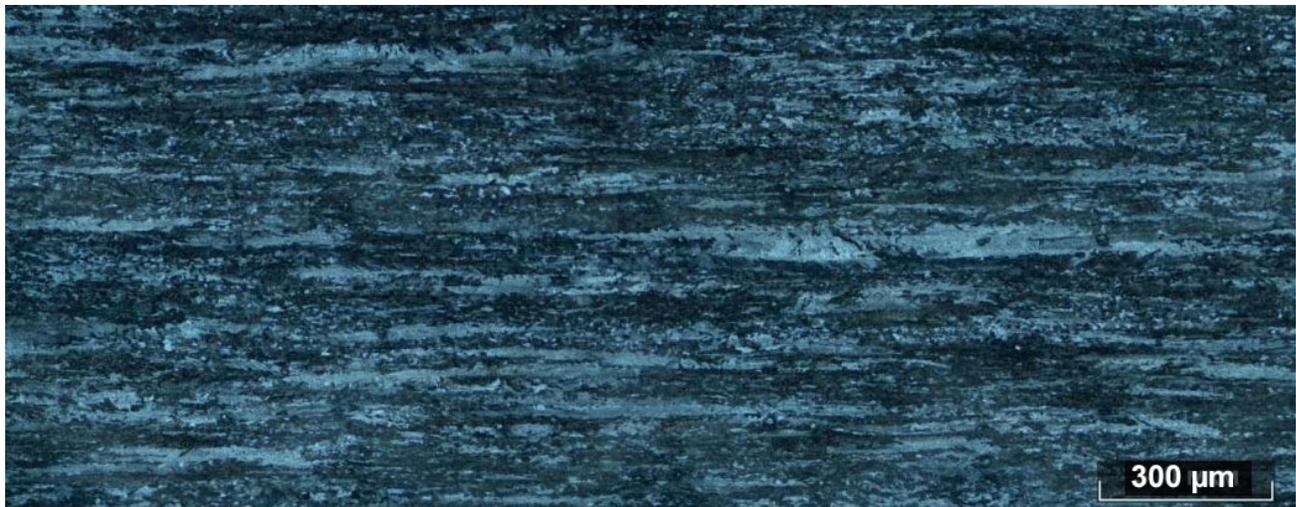
a)

Fig.1. Microstructure of pipe plate etched with 10% aqueous SMB in polarized light (a) and the fields of coarse lath morphology bainite regions, revealed by the color thresholding feature (b).

The method of revealing lath morphology bainitic regions with successful estimation by image analysis was developed. 10% aqueous sodium metabisulphite (SMB) solution was used for tint etching. Further investigations were carried out in polarized light of optical microscope at 200X magnification (Fig.1a) using color thresholding feature of Thixomet Image Analyzer (be consistent with next paragraph) to reveal the fields of coarse lath morphology bainite (Fig.1b).

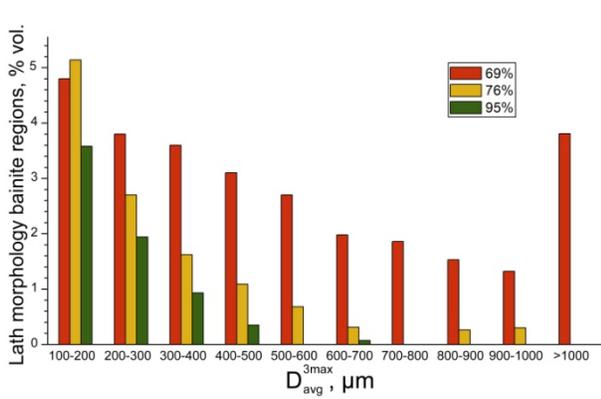
Fig.2. The results of the drop weight tear test at -20°C (a) and impact number at -40°C (b) versus volume fraction and the length of the of lath morphology bainite regions.

It was determined that the results of the drop weight test at -20°C were well defined by the volume fraction and the length of the lath morphology bainite regions (Fig.2a). There are large volume fraction and elongated interphase boundaries of bainitic regions with lath morphology (800-1000 μm and higher) in the structure of steels with low value of ductile fracture. In order to provide high values of ductile fracture (95%) after DWTT the fraction of lath morphology bainite in the structure of steel has to be minimized and only single regions in length no more 500-700 μm are permitted (Fig.2a). Similar behavior was obtained during investigation of the samples after impact test at low environmental temperatures (Fig.2b).
